Condition Assessment

Report prepared March 2023

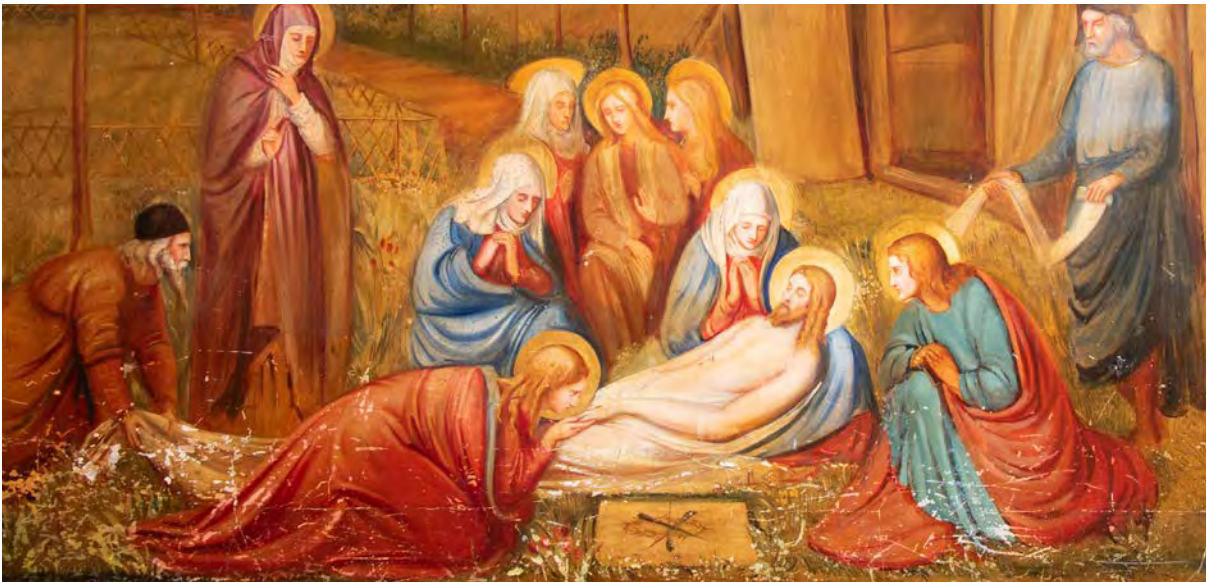
Site	Sacred Heart High School, Hammersmith, W6
Listing	Grade II*, 1192062
Object	Cloister Paintings
Material	Paint (oil) on plaster
Artist	Mother Mary Maycock, 1902-3 or 1906-7
Size	Approximately 130m length x 3 m
Size	1-2 February 2023

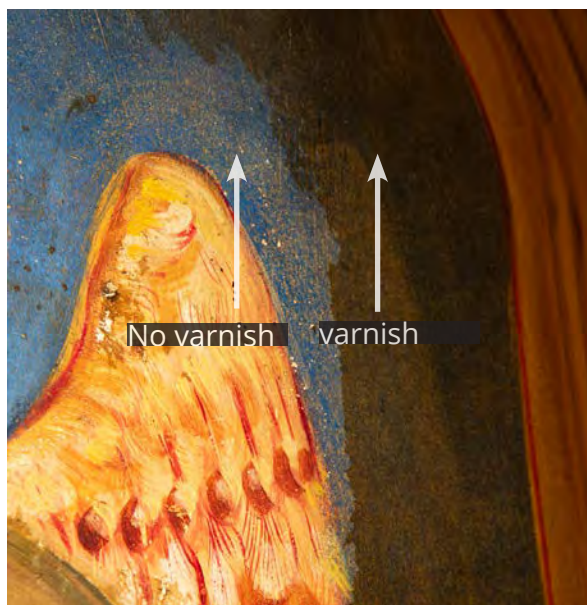
Fig.1 Yellowing and darkening caused by the varnish can be seen clearly where it has been removed and where it remains. The area to the right is blue under the varnish.

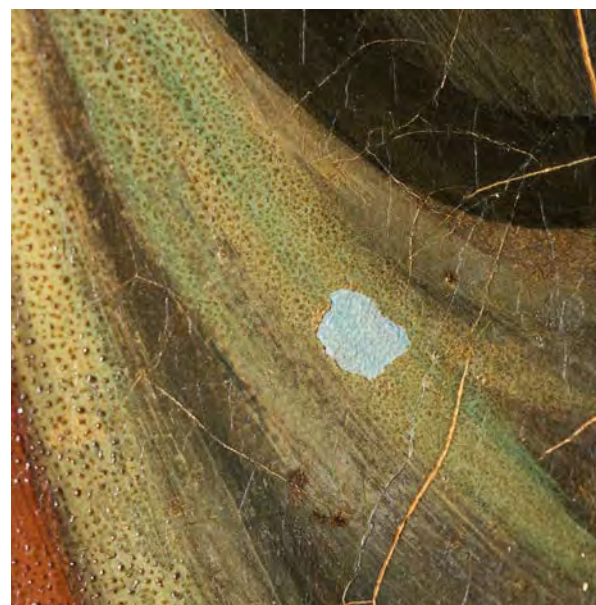
Fig.2 A closer detail showing how the varnish is effecting the appearance of the paintings. Where it is lost the true colour can be seen.

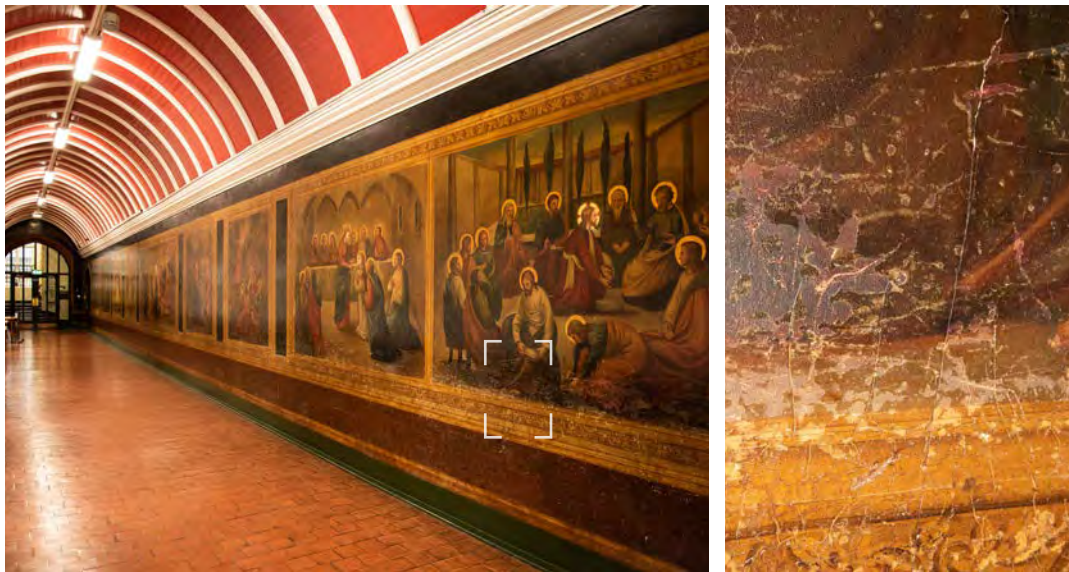
Fig.4 View of the north corridor where damage from passers-by is most evident.

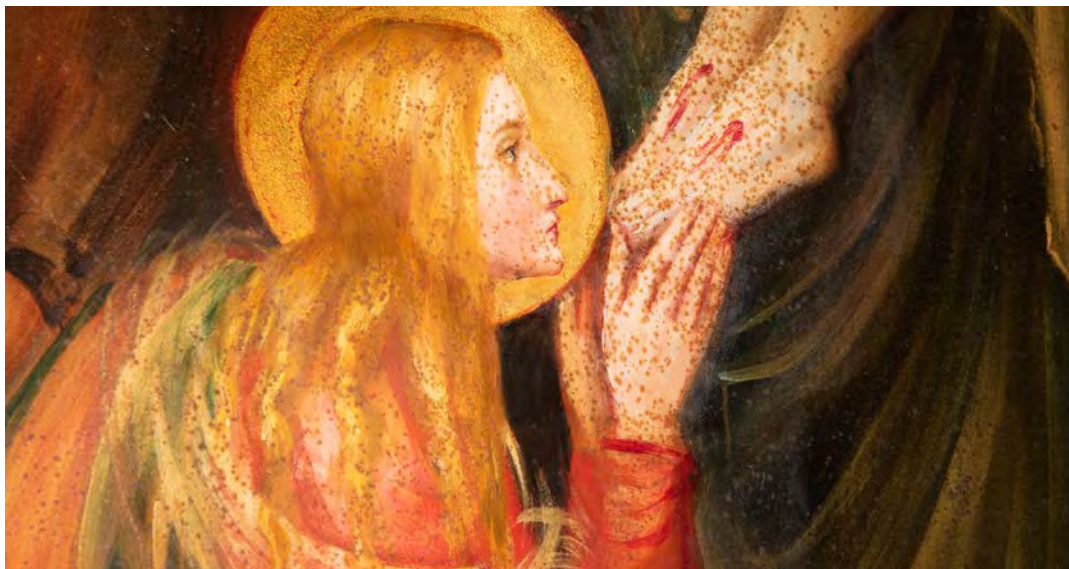
Fig.5 Detail of an area of spotting.

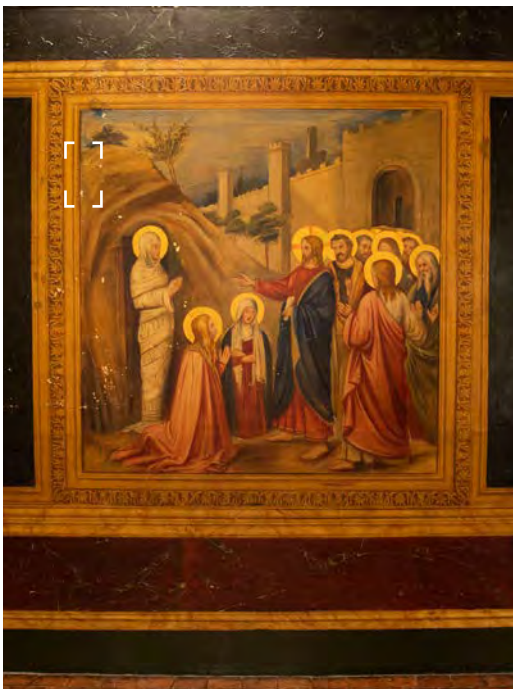
Fig.10 Detail of the east wall where blistering and flaking paint is concentrated. It would appear this is due to a localised cause. Possibly water infiltration.

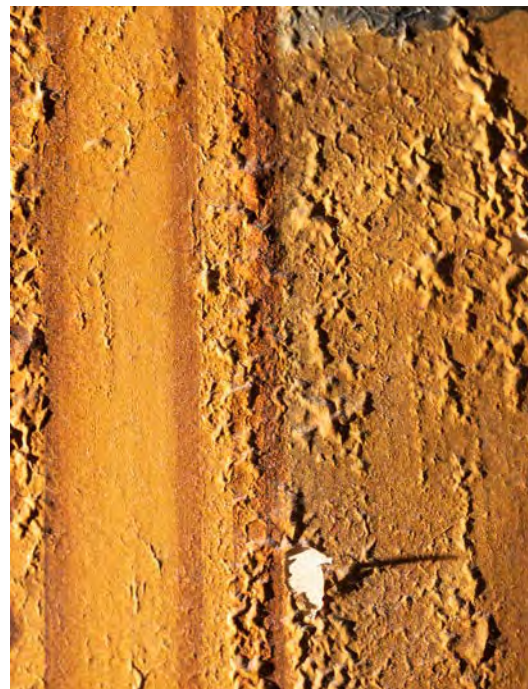
Fig.11 Detail of area marked in image to the left.

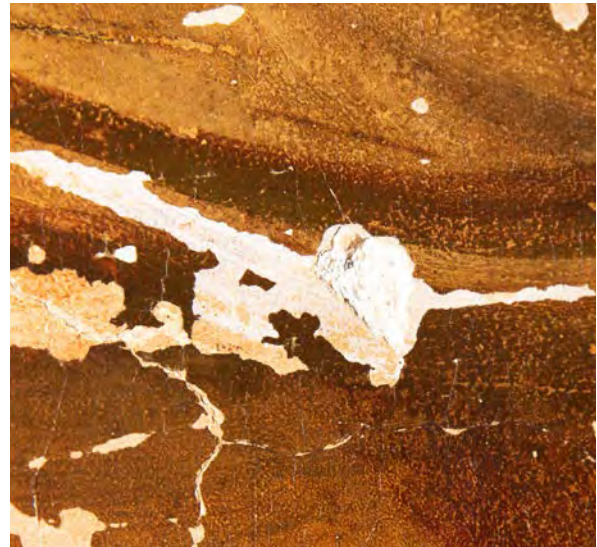
For example: as a result of an accidental gauge.

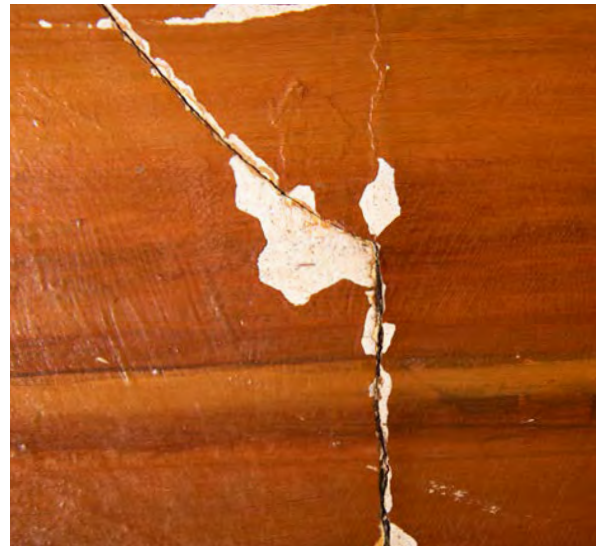
An open fissure in the substrate of a painting. May or may not have associated loss.

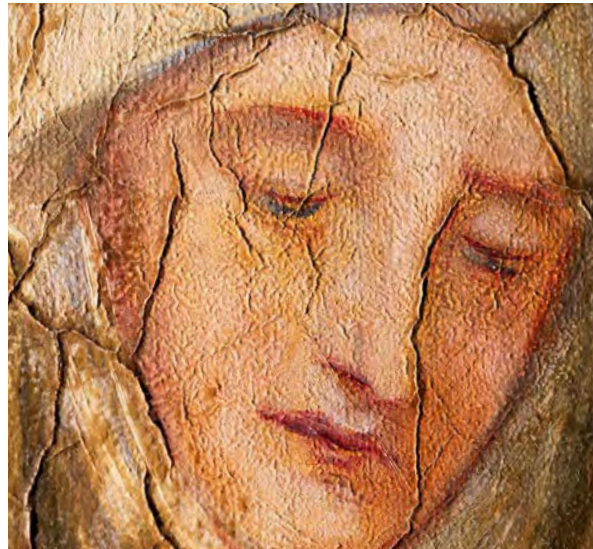
Differentiated from craquelure as raised lines in the painting without any hairline crack.

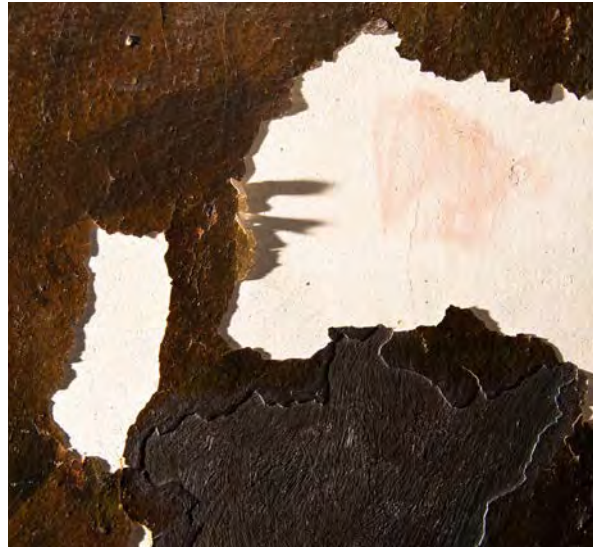
Part of the paint layer is missing.
Associated with flaking or blistering.

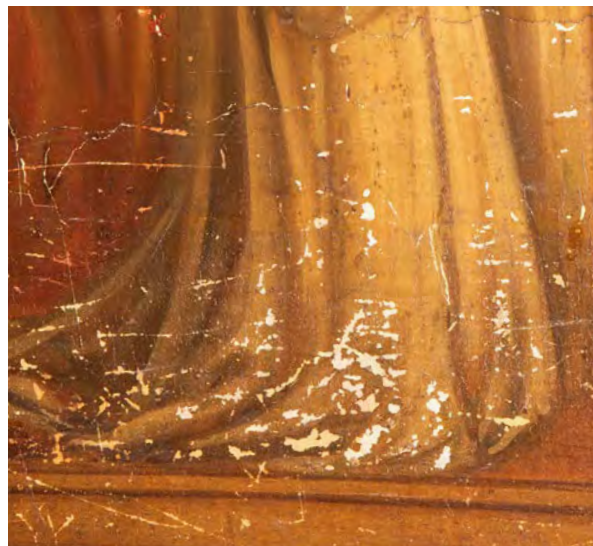
Part of the paint layer is missing.
Associated with scrapes / knocks from passers-by.

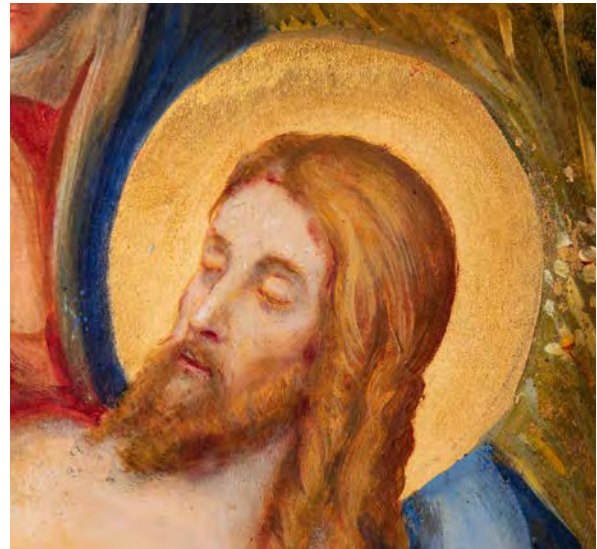
Image: Christ's cross halo in red has gone.

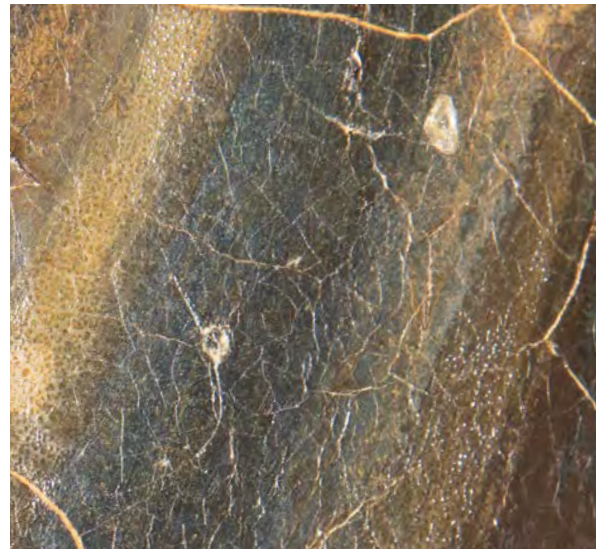
Image: example of the finer network of cracks.

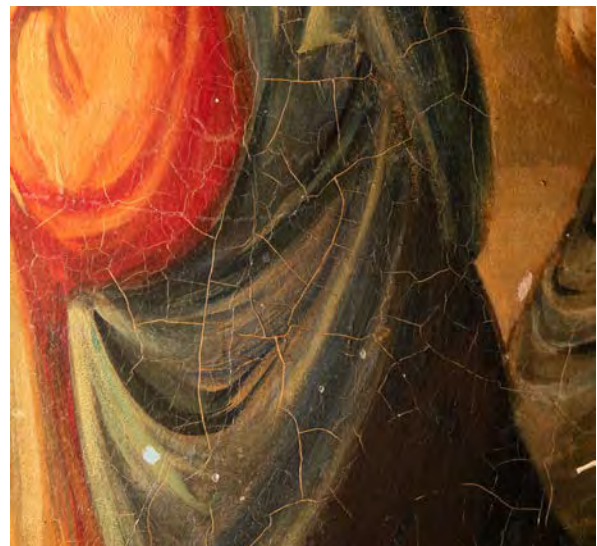
Image: example of the larger network of cracks.

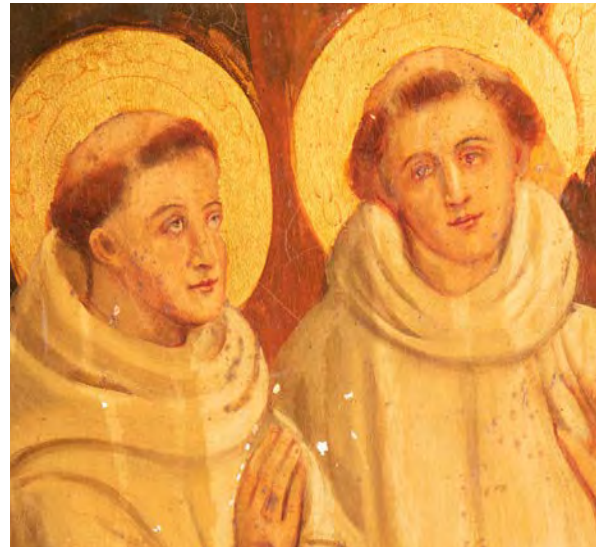
Image: The yellowed and darkened appearance of the paintings is apparent in the robes where vertical patches are a result in changes in the appearance of the varnish layer.

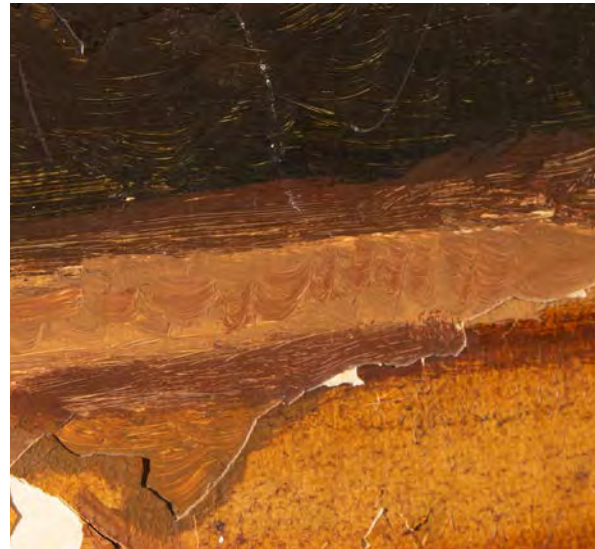
Areas of damage or loss that has been restored. Often distinguishable due to difference in texture, quality or colour to the surround

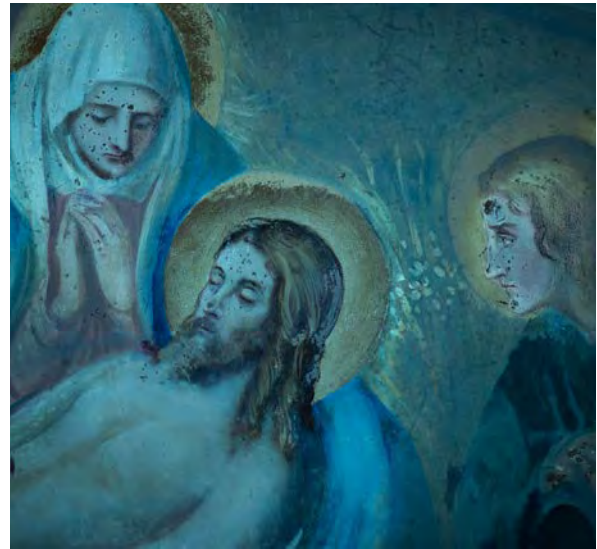
UVF image shows blue/ green fluorescence caused by the presence of the varnish. Dark spots not related to composition are areas of repainting.

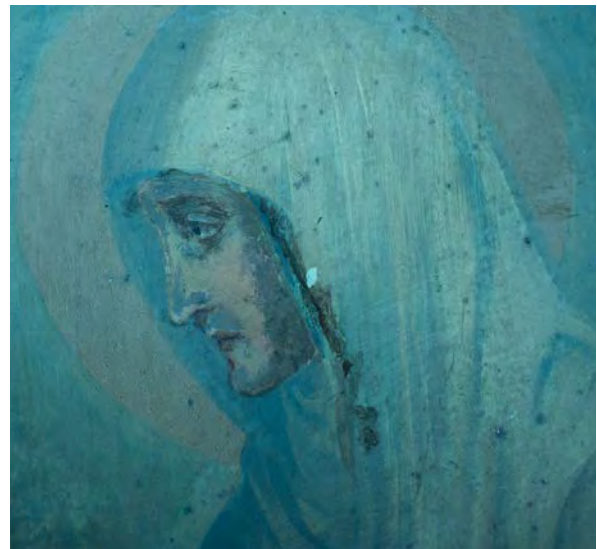
UVF image shows blue/ green fluorescence caused by the presence of the varnish. The area where the varnish has been removed is darker and more contrasted due to absence of fluorescing varnish.

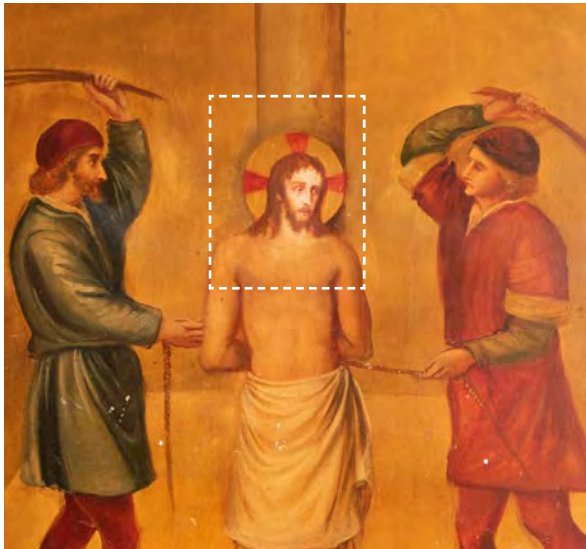
Ultraviolet Fluorescence Images (UVF) continued

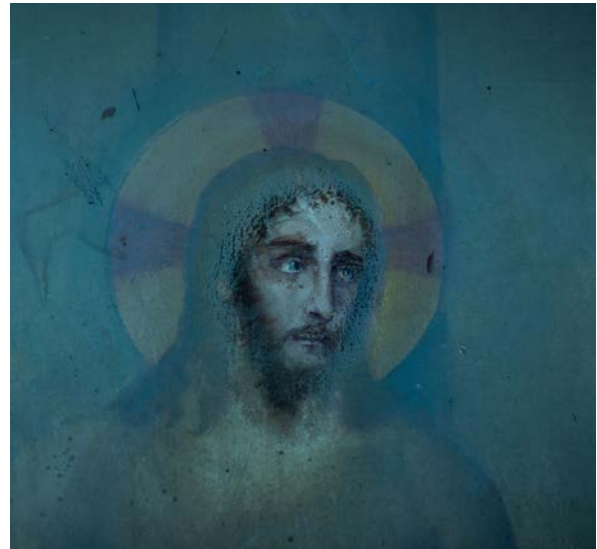
UVF image shows blue/ green fluorescence caused by the presence of the varnish. Dark spots not related to composition are areas of repainting.

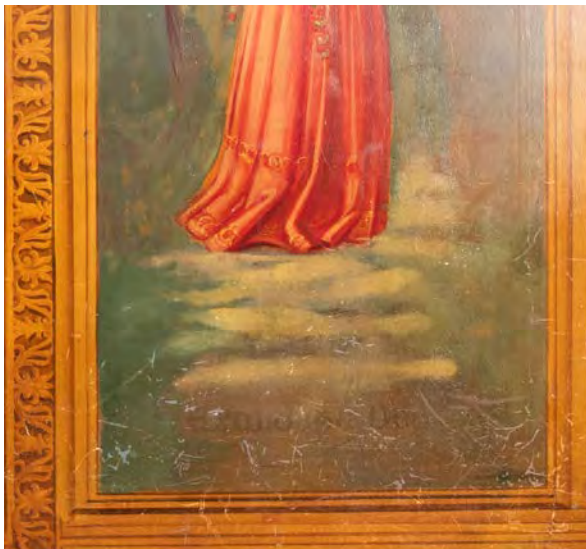
Infrared reflected image
